Client: Chicago Dept. of Fleet and Facility Management
Location: Ingersoll Products, 1000 West 120th Street, Chicago IL
Photograph Date: December 20, 2011

Project Number: 144607.01
Photographer: Trevor Hornbacher

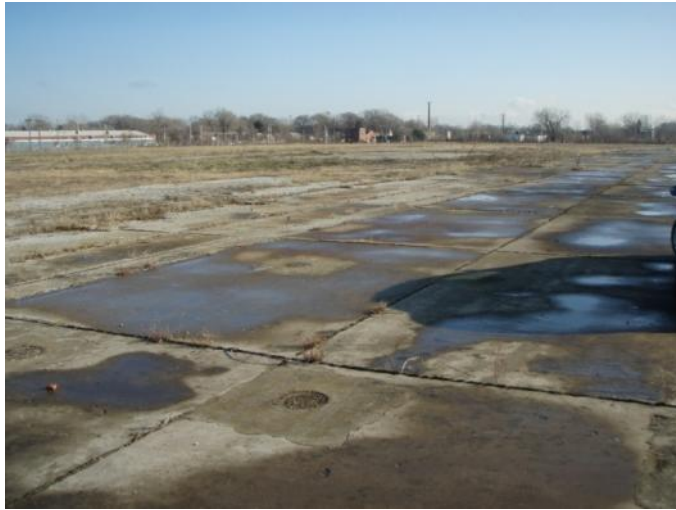
Photo No: 1 **Picture Direction: NE**

Description: View of concrete building floor slab (Bldg 1018) located in southwest corner of Subject Property.

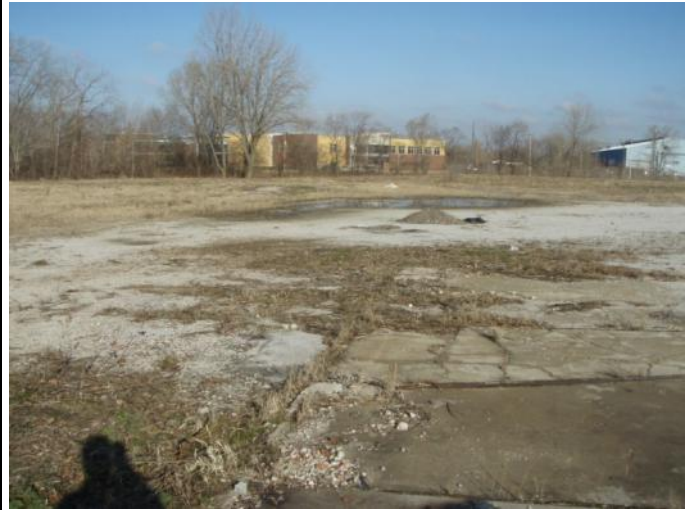
Photo No: 2 **Picture Direction: NW**

Description: View of gravel drive and concrete building floor slab (Bldg 912) located in west side of Subject Property.

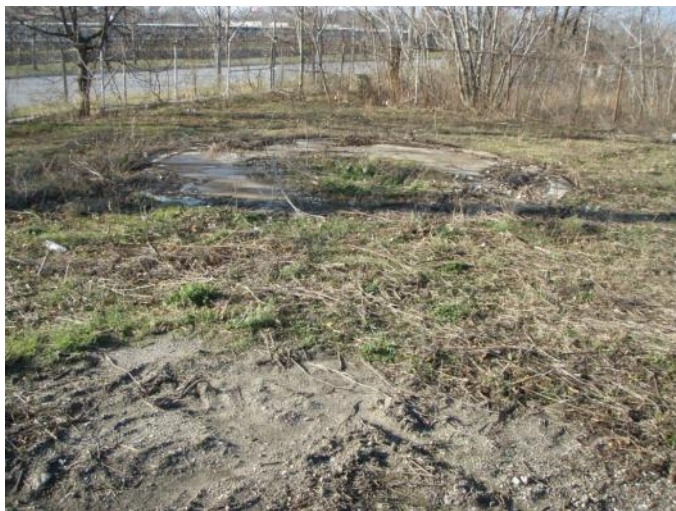
Photo No: 3 **Picture Direction: SW**

Description: View of concrete water tower foundation (Bldg 1117) located in southwest corner of Subject Property.

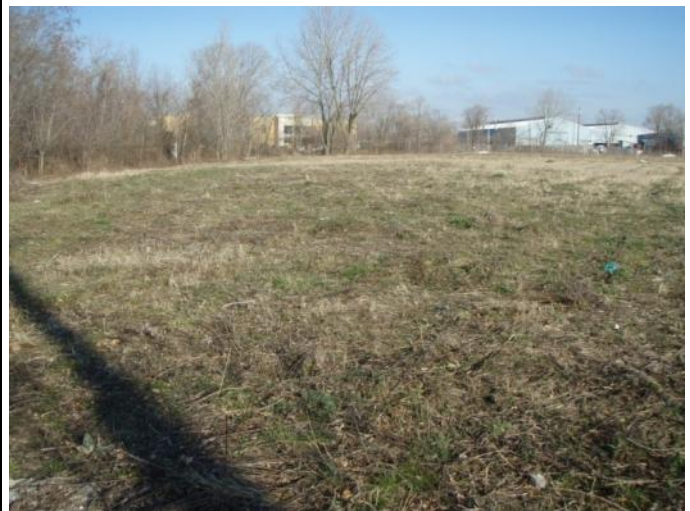
Photo No: 4 **Picture Direction: N**

Description: View of western Subject Property boundary area.

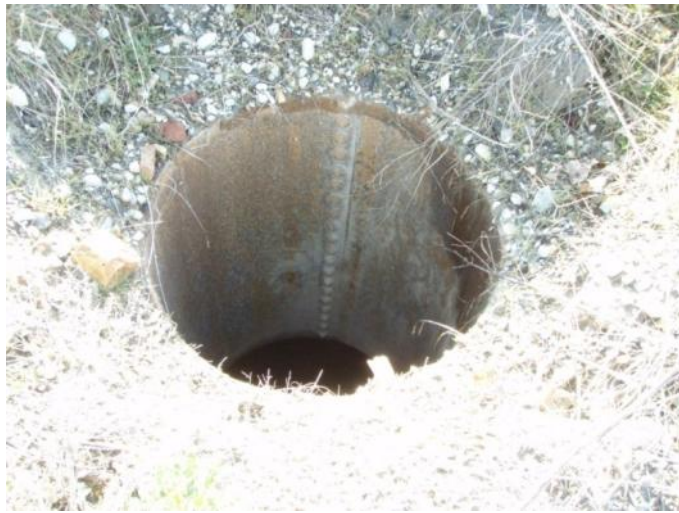
Photo No: 5

Description: View of likely abandoned in-place UST located in the northwestern portion of Subject Property - north of Bldg 924. (one steel-lined down hole about 2 to 3 ft in diameter, depth unknown filled with water)

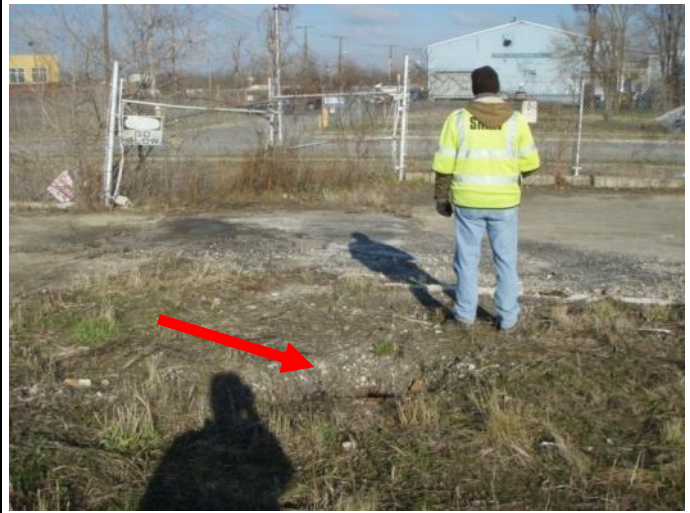
Photo No: 6

Description: View of likely abandoned in-place UST same as Photo 5, located about 70 feet east of the west AxleTech Building wall and north of former Bldg 924.

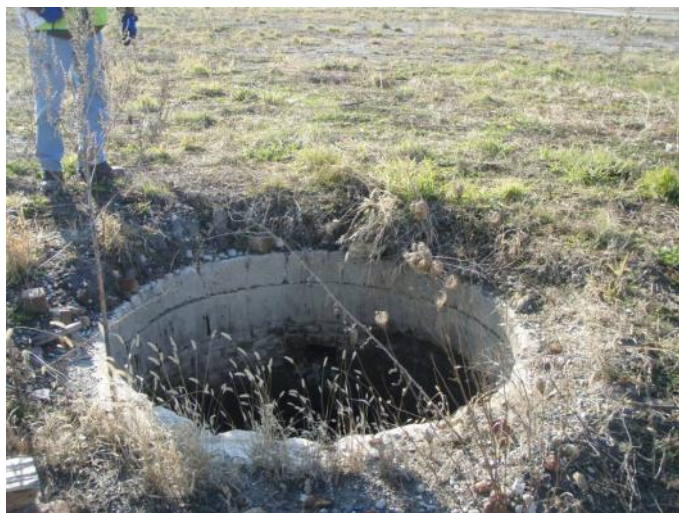
Photo No: 7

Description: View of likely abandoned in-place Sump/UST located in northwestern portion of Subject Property, north of Bldg 924. (one brick-lined down hole about 4 to 5 ft in diameter, depth unknown, filled with water)

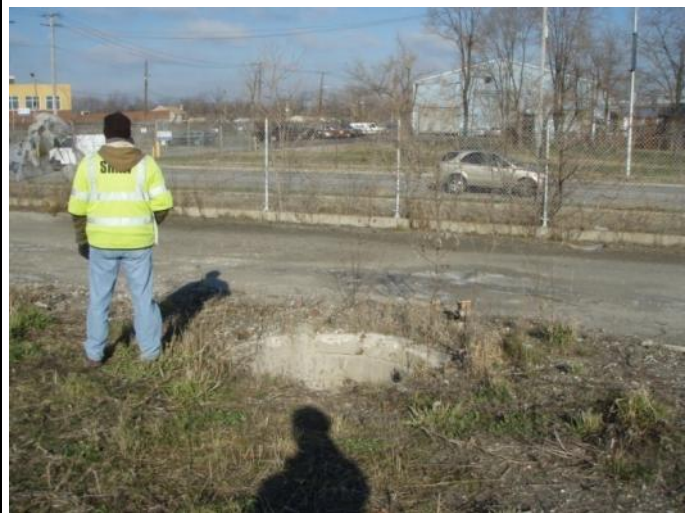
Photo No: 8

Description: View of likely abandoned in-place UST same as Photo 7, located about 120 feet east of the west AxleTech Building wall and north of former Bldg 924.

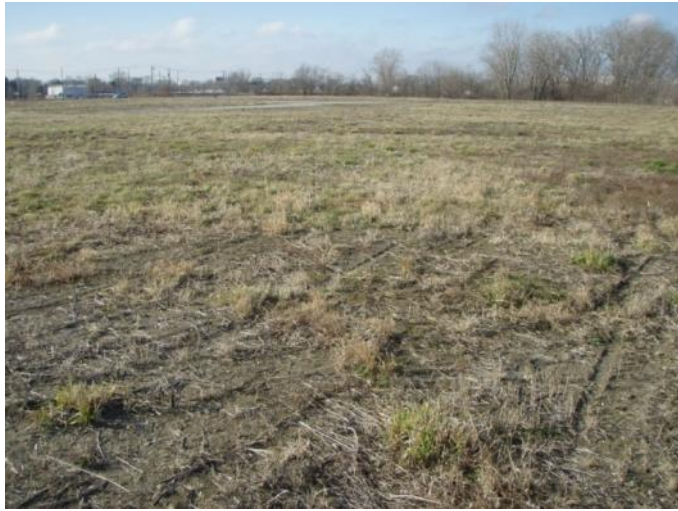
Photo No: 9 **Picture Direction:** SW

Description: View of gravel and grass covered area in the northern portion of the west half of Subject Property, beginning about Bldg 914 and westward.

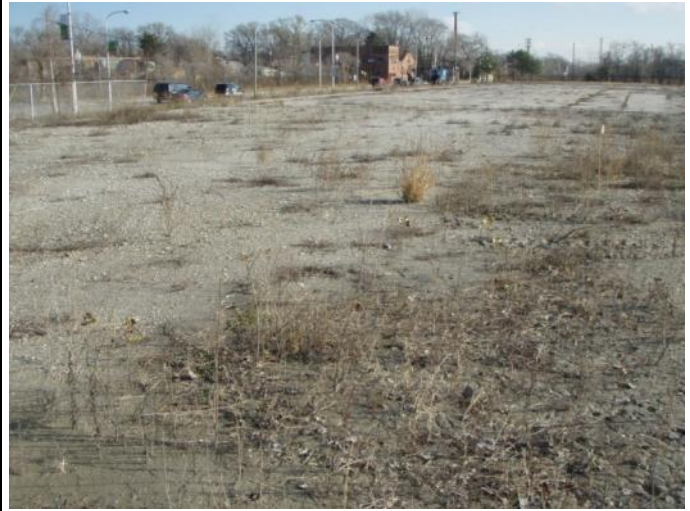
Photo No: 10 **Picture Direction:** NE

Description: View of the gravel and concrete floor slab covered area in the northern portion of the east half of the Subject Property, beginning about Bldg 920.

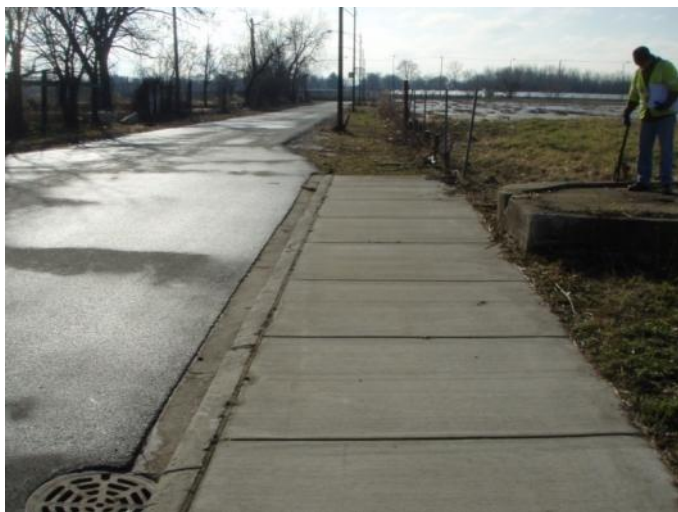
Photo No: 11 **Picture Direction:** S

Description: View of northeast corner of Subject Property and eastern Subject Property boundary along South Morgan Street.

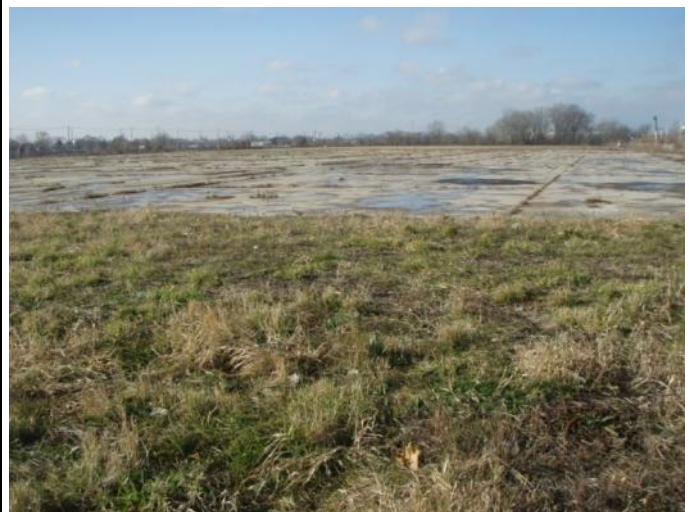
Photo No: 12 **Picture Direction:** SW

Description: View of Subject Property from the southwest corner of West 119th Street and South Morgan Street

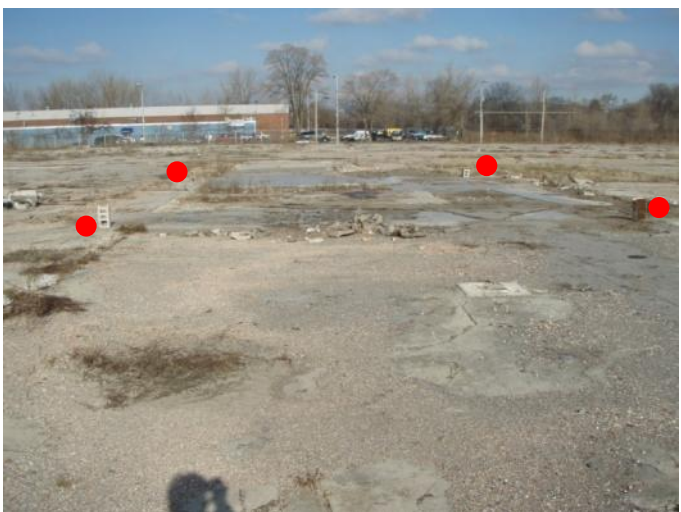
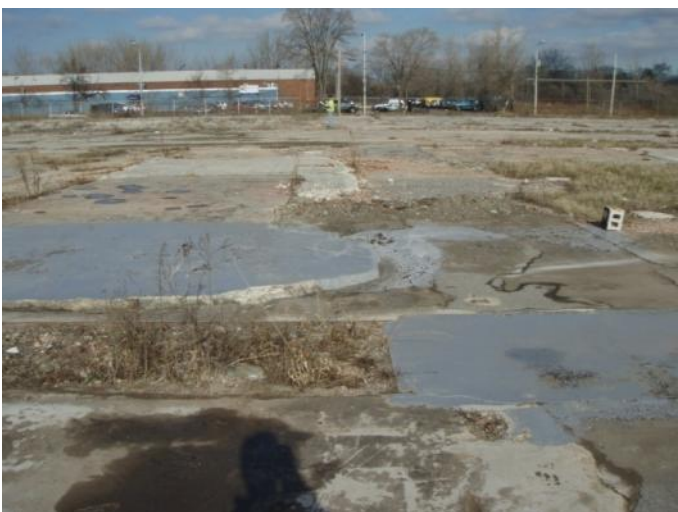
<p>Photo No: 13 Picture Direction: S</p>	<p>Photo No: 14 Picture Direction: W</p>
<p>Description: View of typical subsurface feature, filled with construction demolition debris. (Bldg 511 vault)</p>	<p>Description: View of concrete area of Bldg 1014 having 1 primer coat and 2 grey epoxy coats, which encapsulates TSCA regulated PCB-contaminated concrete. PCB-contaminated soils are also located in this area.</p>

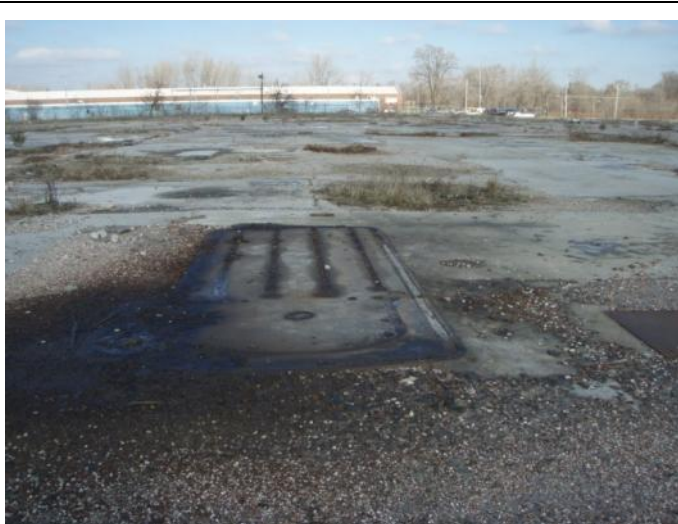
Photo No: 17 **Picture Direction:** E

Description: View of oil-stained concrete and former transformer pads located in Bldg 511. Previous collected PCB wipe samples identified this as PCB-containing and a TSCA regulated area.

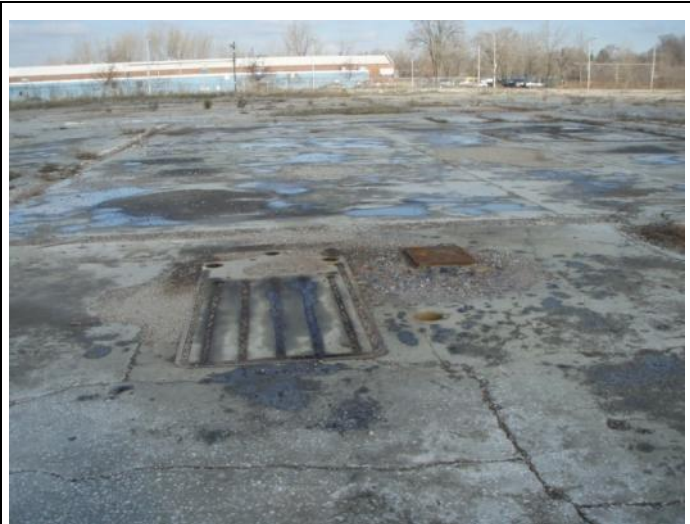
Photo No: 18 **Picture Direction:** N

Description: View of oil-stained concrete and former transformer pads located in Bldg 511, north of Photo 17. Previous collected PCB wipe samples identified this as PCB-containing and a TSCA regulated area.

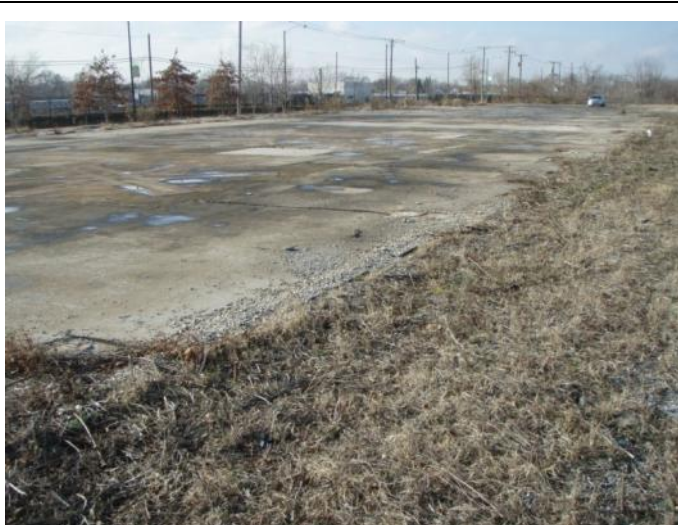
Photo No: 19 **Picture Direction:** SW

Description: View of concrete floor slab associated with Bldg 1018 – former Electromelt Foundry. Oil staining observed on concrete. Pondered liquids observed were water from previous rain event.

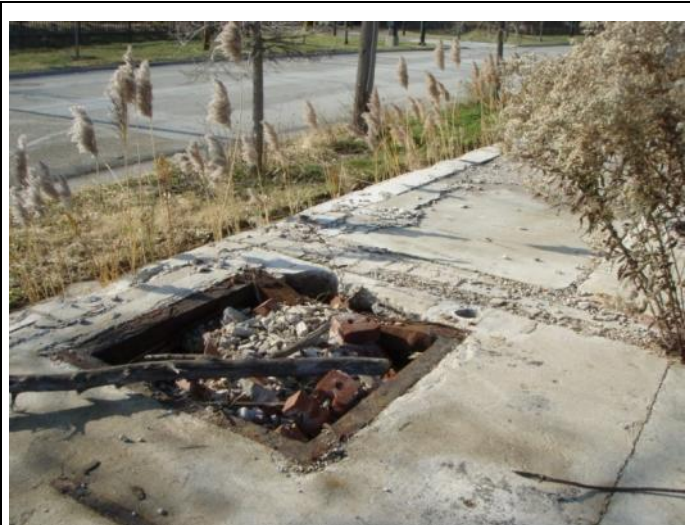
Photo No: 20 **Picture Direction:** SW

Description: View of typical subsurface feature located in Bldg 1018 and filled with construction demolition debris.
